Manhole Inspection Summary

Manhole # S21CC_036MH

Insp Date: **10/24/07 1:26 PM**

Location Address: **1912 RIGGS-MOSHER**

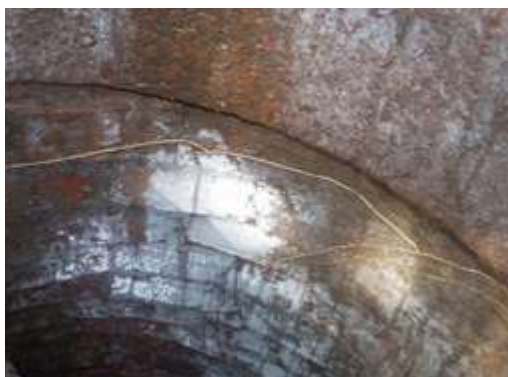
Defect 4

Condition: ☐ Sound ☐ Cracked ☒ **Root Intrusion** ☐ Loose Brick ☐ Deteriorated

ROOTS INTRUDING /CORBEL AND BARREL

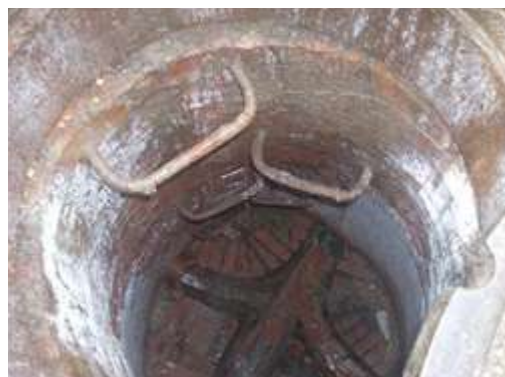
Defect 3

Steps Count: **5** Missing: **0** ☒ **Corroded**

CORRODED STEPS

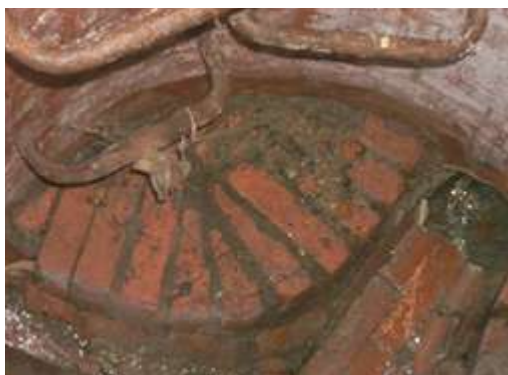
Defect 2

Surcharge ☒ **Evidence Of Surcharge** Depth: **3** (ft.) ☐ Active Surcharge Present

SURCHARGE EVIDENCE

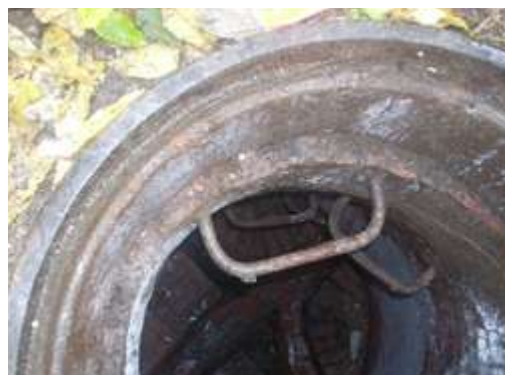
Defect 1

Frame Offset: **1** (in.) Condition: ☒ Sound ☐ Cracked ☐ Leaks

FRAME OFFSET
